FIELD INSPECTION REPORT

Project Name:	Mountain Valley Pipeline	Inspector:	Matthew Grant
Inspection Date:	Monday, August 3, 2020	Project Contact:	Brian Clauto
Spread H: Montgomery	MP 230.6-230.9 AR MN 274 & 275 ATWS-703, 704, 704a, 1446,1052, 1375, 1331, 471	Weather:	Rainy

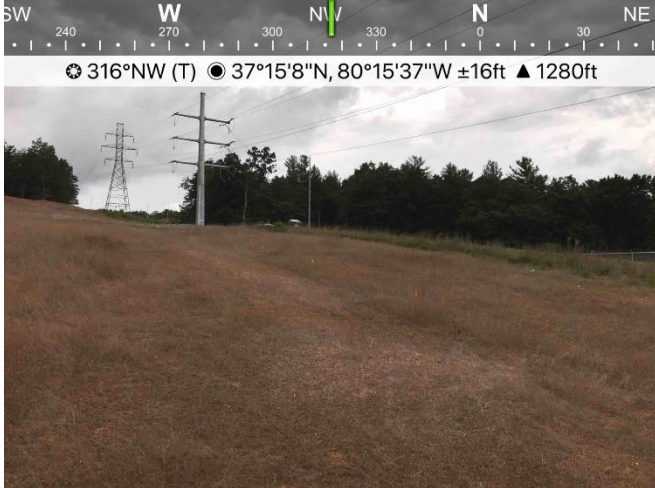
- Figure 1: Near MP 230.6 ECD's and stabilization was in place and functioning.

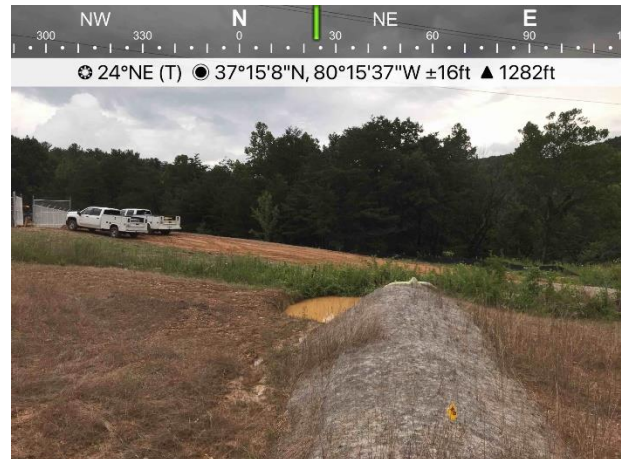
- Figure 2: Near MP 230.6 waterbar end treatment functioning per design.

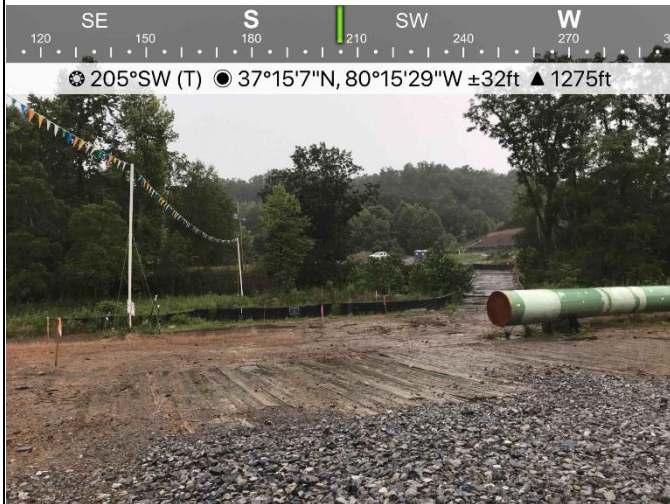
- Figure 3: At ATWS 704A controls in place as well as controls in place for designated stream S-C21.

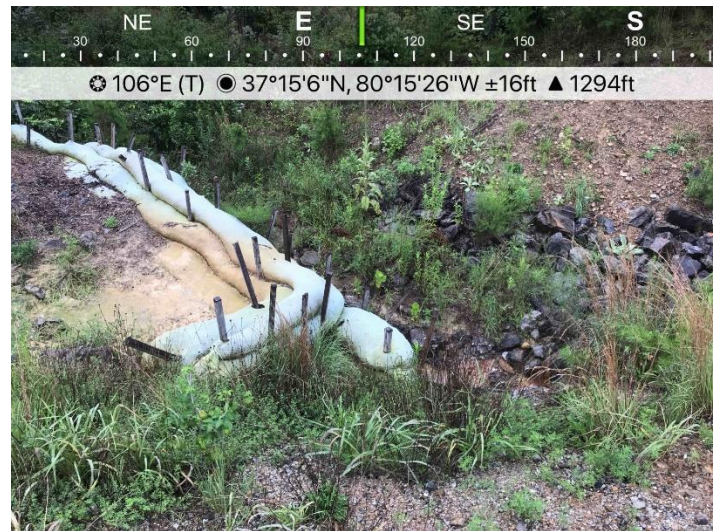
- Figure 4: Controls in place near designated stream S-E20
